Quality Alert

Failed wall 2

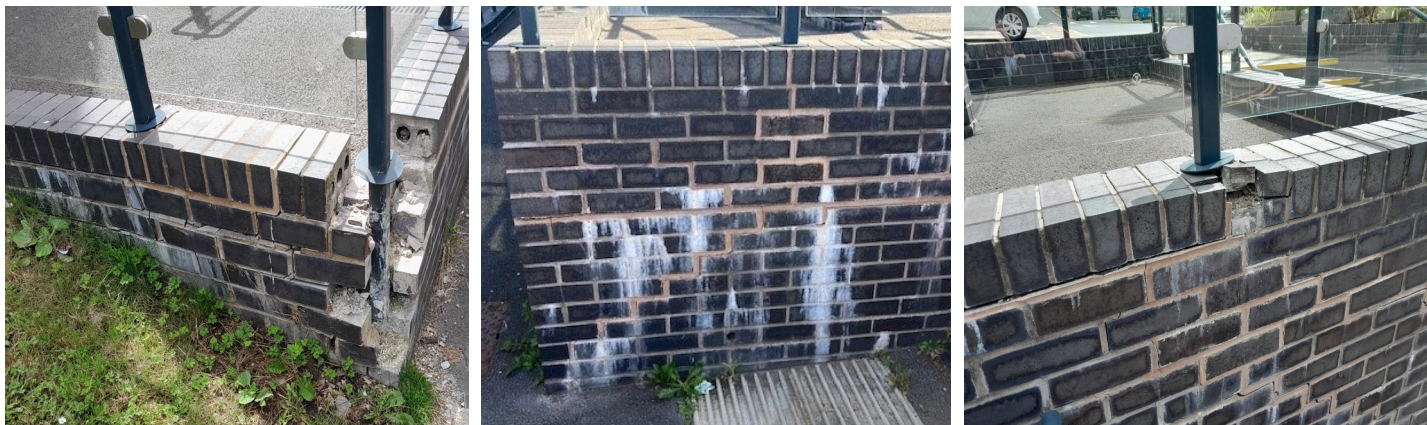
Initial inspection found the following:

1. Debonded brickwork
2. Extensive horizontal and vertical / stepped cracking
3. The grout used to retain the balustrade posts was crumbling and holding moisture (expanding grout used)
4. The balustrade post have been set into a 225 mm wall structure
5. No Substructure drainage behind the wall was installed at the time of build

1. The wall has been built mainly to the Architect detail instead of the structural engineers drawing
2. The structural engineers drawing showed a different installation all together
3. When the install was questioned with the structural engineer it was deemed as unsound and needs redesigning.
4. No evidence found of agreed changes to the wall design
5. Some drain holes were cored in later but do not pass through into the substrate
6. Drainage channel was installed to the ramp to capture surface water

Outcome: The wall is to be rebuilt at cost to Morgan Sindall's
