Quality Alert

Failed wall 1

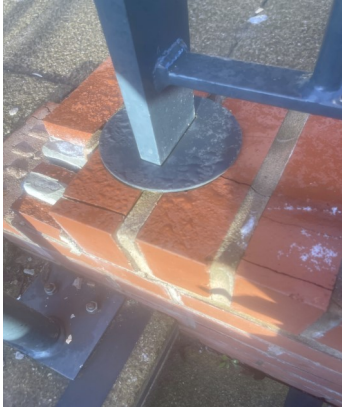
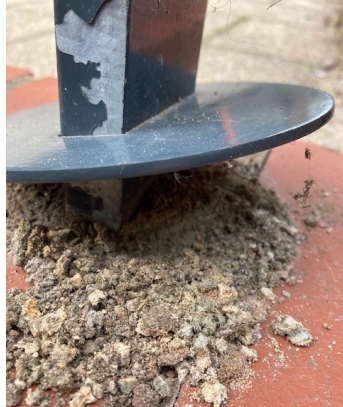
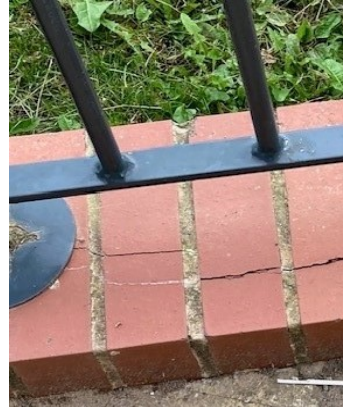
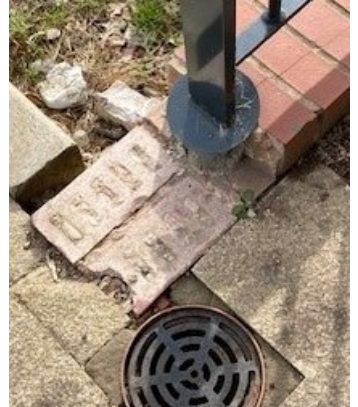
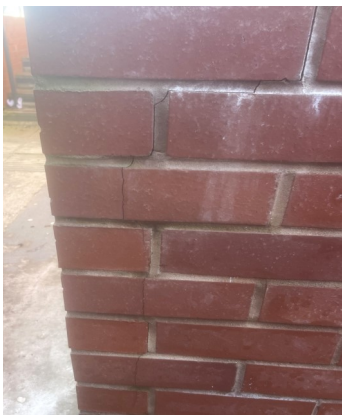
The initial inspection of the wall found the following:

- Cracks to some bed joints
- Horizontal cracking between the balustrade posts through the class B brickwork
- The grout used to retain the hand rail was retaining moisture and crumbling
- Brickwork debonded
- Water ingress through the wall structure

1. Was not built in accordance with the drawn design, see drawing section below
2. The wall structure was left low to allow 225 mm brickwork to be built on top, should have been a capping, the rear was not tanked and no weep drainage or any records of a land drain
3. Information past to the structural engineer was not quite correct regarding changes which got agreed

Outcome : the wall is to be rebuilt at a cost the Morgan Sindall

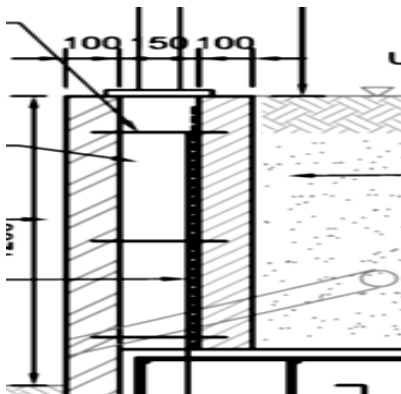
Original drawn section with the balustrade set central to the wall

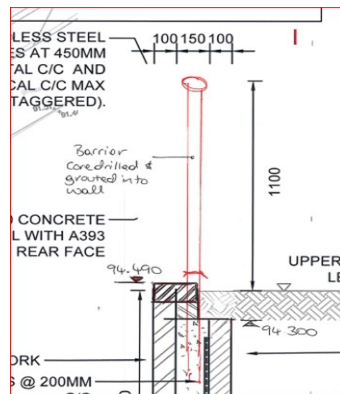
Information issued for sign off showing the hand rail in the centre of the concrete and on the outer edge of the brickwork

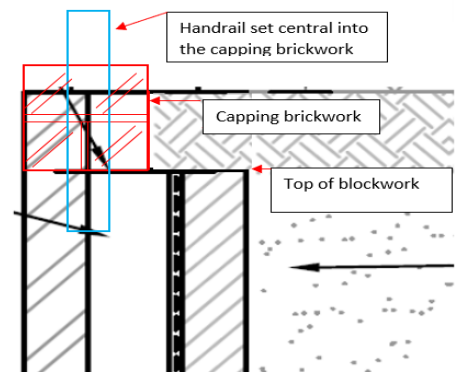
The detail below is the actual installation
