## Entrance canopy failure

### Summary

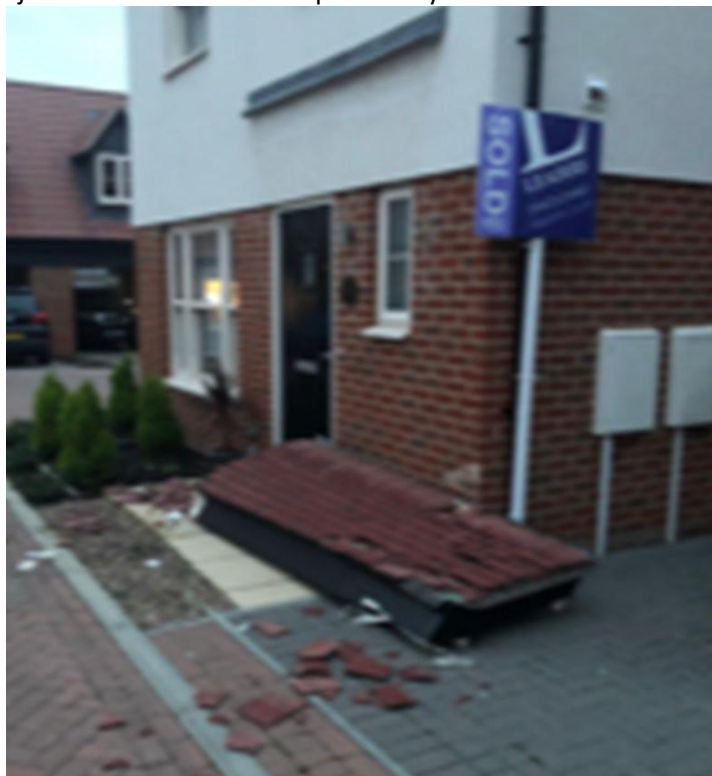
- Fully tiled, timber entrance canopy failed on a Friday evening falling to the ground at the front door of an occupied property. ([Image 1](#))
- The timber gallows brackets and wall plate had been fixed using only 100mm woodscrews and brown rawl plugs instead of M10 bolts as specified in an engineer's design. ([Image 2](#))
- The construction of the canopy was not wholly in accordance with the architect's design. ([Image 3](#))
- The construction of the gallows brackets was not in accordance with the engineer's design. ([Image 4](#))
- No injuries sustained however potentially far more serious consequences.

Image 1 - fallen canopy

- Entrance canopy collapsed on a Friday evening although the exact time is unclear. The project itself was completed and occupied in 2019.
- There had been strong winds in the area days before the incident although it was not particularly windy at the time it failed.

- Suitable and sufficient risk assessments and associated method statements (where appropriate) must be provided for all significant works by our supply chain which must undergo our RAMS review process prior to commencement. A method statement may have detailed the intended fixings.

- A dedicated structural design which clearly details fixing requirements must be prepared for any independent fitting fixed to the building fabric, such as entrance canopies or porch roofs etc.

- The structural design must be co-ordinated with architects' drawings to ensure compatibility.
- Where porches, canopies and other such additions are specified on national house type designs, they must include standard co-ordinated construction and fixing details for each and every type to be used.

- The approved, current construction issue drawing must be distributed to all involved parties, especially the manufacturing/joinery company and contractor involved in constructing and fixing the item.

- Fixings must be exactly as specified within the approved design and fitted at the correct centres. It is strongly recommended that Lovell supply all structural fixings of this nature thus providing additional control to ensure correct fixings are used.

- Build stage checking/QMS monitoring must include checking the construction and installation has been completed in accordance with the approved design.

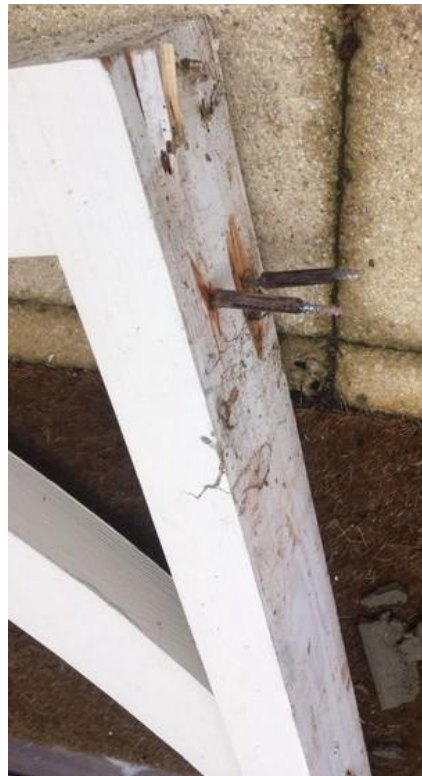
Image 2 - gallows bracket

- Engineer's gallows bracket detail was a generic design which details use of a galvanised mild steel strap notched and securely fixed into the back of the timber (Image 4). The design shows the brackets are to be fixed using 3no. RAWL M10 bolts with R-KF2 resin although bolt length was not stated or requested. The gallows brackets were fixed using 100mm woodscrews with brown rawl plugs (Image 2).

- The joinery company who constructed the gallows brackets were issued the architect's drawing but not the engineer's design, subsequently the brackets were not constructed in accordance with the structural design.

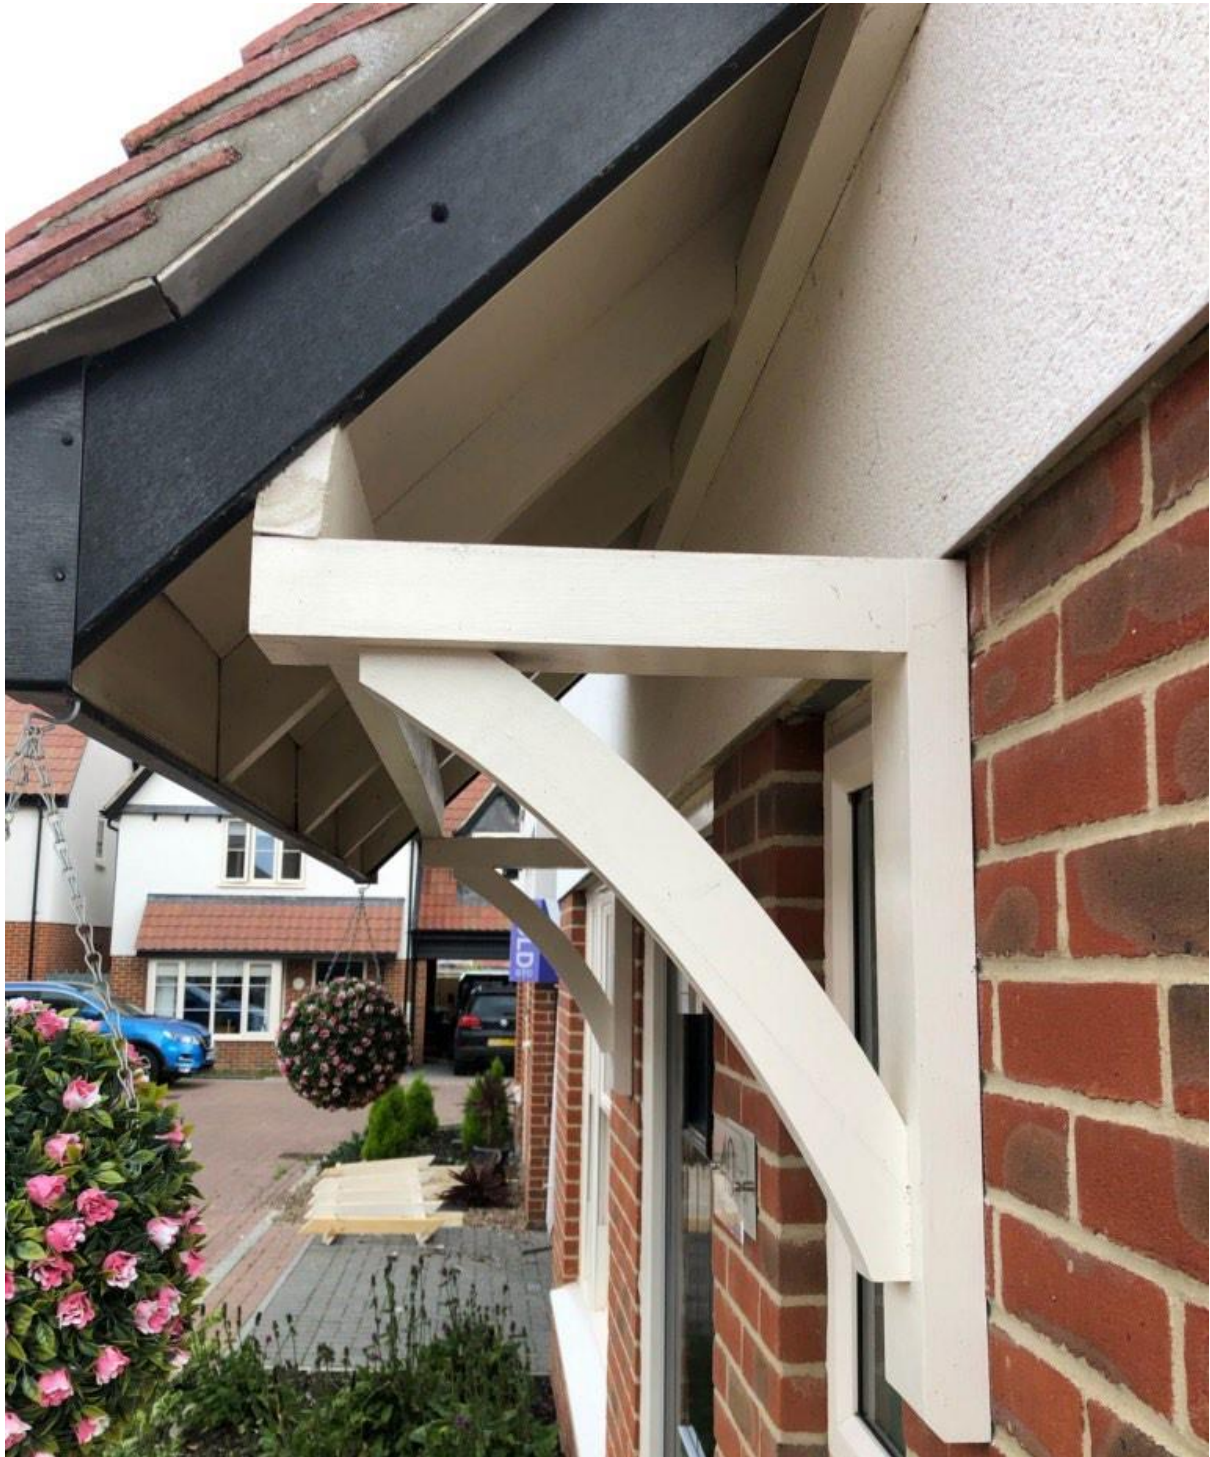
- The canopy was not constructed in accordance with the architect's drawing with regard to the eaves beam detail. 2no. 47mm x 150mm timbers bolted or screwed together using M10 anchors at 300mm centres were detailed ([image 3](#)), however only a single 50mm x 100mm was used ([Image 5](#)).
- No records of build stage quality checking are available for this plot's canopy installation, or for any other.

[Image 5](#) - neighbour's entrance canopy in situ

**Urgent checks must be made to ensure similar installations are securely fitted in accordance with the above practices, including completed properties on live projects.**
