Quality Alert

Nickel Sulphide Inclusion in Glass

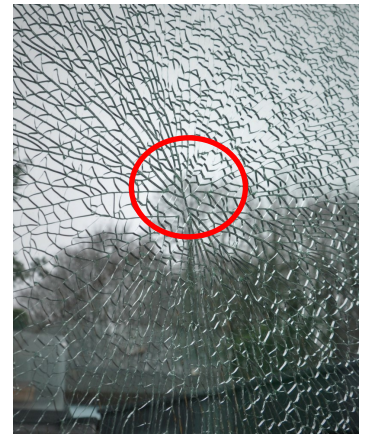
The image to the right shows the classic signs of a glazed unit that has been subject to a nickel sulphide inclusion. The centre of the breakage can resemble the shape of a butterfly, however the only definite way of confirming this is to test the glass by a specialist provider.

Toughened units are susceptible to spontaneous breakage from inclusions within the glass, this is not a manufacturing defect as such, it is a naturally occurring phenomenon within glass production and cannot be prevented or detected at production stage. However heat soaked toughened glass does reduce the probability

To be 100% certain to remove the risk of inclusions in the glass would be to use heat strengthened laminate which can be up to 15% more in cost per unit.

- Nickel sulphide inclusion is naturally occurring
- It can be fully ruled out of being an issue if heat strengthened laminate is used
- It only tends to happen on average in the first 6 years from manufacture and then appears to go dormant
- If a breakage does occur then there is a test that can determine if nickel sulphide was the cause
