Quality Alert

Recessed manhole lid location within vehicle trafficked paved areas

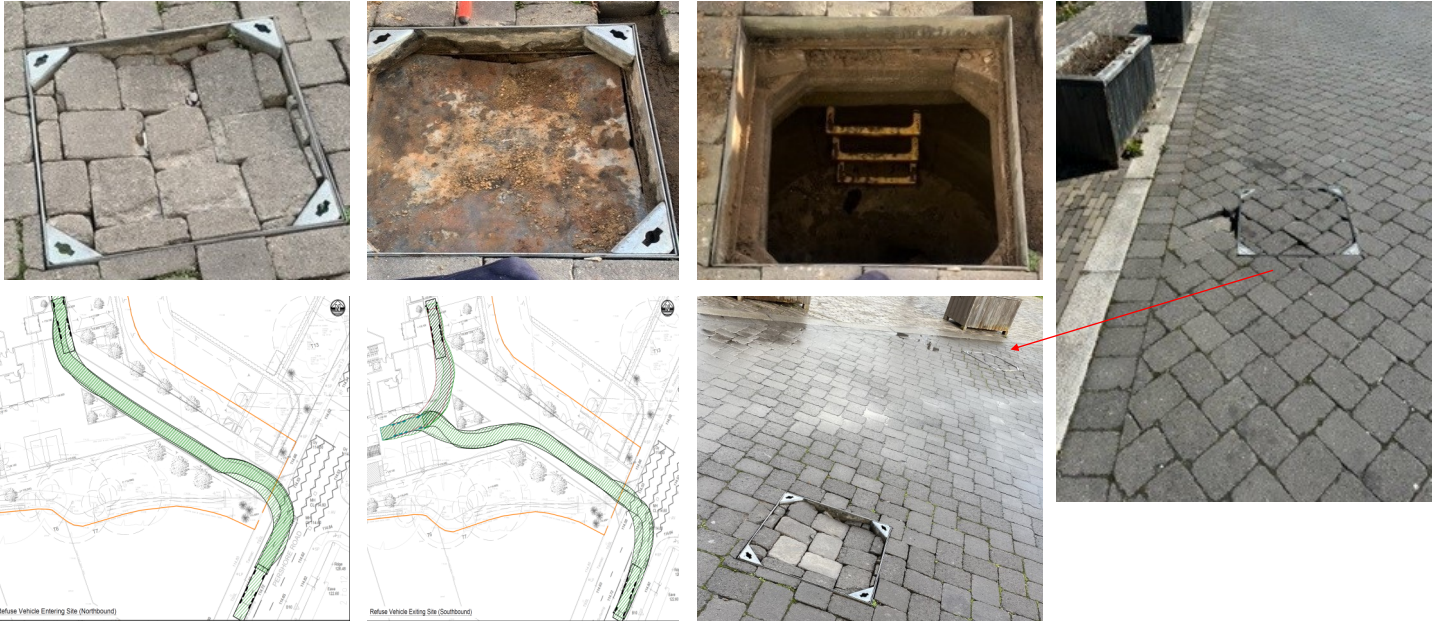
A number of defects have been raised regarding failures of recessed manhole covers, especially in vehicle trafficked paved areas, even though they are the correct heavy duty type:

- ◆ Location on the line where the tyres run
- ◆ Point loading where vehicles have stopped
- ◆ Tyre drag on turning areas
- ◆ Heavier vehicles than designed for
- ◆ Tyre pounding, where the pavers have dropped due to the bedding being washed out, increasing the point loading causing the inset part to fail
- ◆ Raising pieces on top of the manhole chamber, not bedded on with a 3-1 mortar and not intact i.e. a complete ring or class B engineering placed to the correct bond with the perforations filled
- ◆ Lack of maintenance by the end user,

- ⇒ Review the drainage design in conjunction with the sweep path analysis
- ⇒ What other vehicle might visit the site and remain static for some time
- ⇒ Can the drainage be better located towards the centre of the road and out of turning circles
- ⇒ Alternative manhole lids solid type

Consider a resin based bedding and grout when setting in the pavers recessed lids
