Quality Alert

Erroneous Fixings- Kalzip Roof - Newcastle Health & Wellbeing

The wrong type of fixings used on the aluminium flashings and gutters to the 'Kalzip' roof at Newcastle Health and Wellbeing Centre (Jubilee 2).

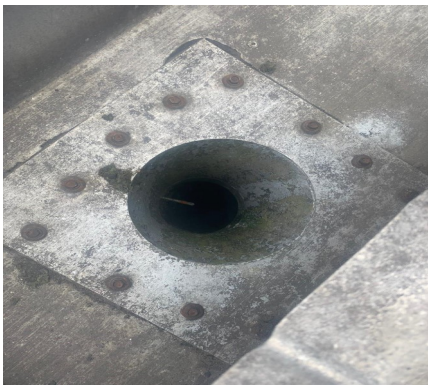
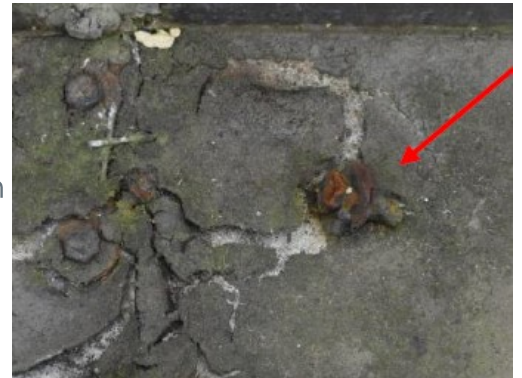
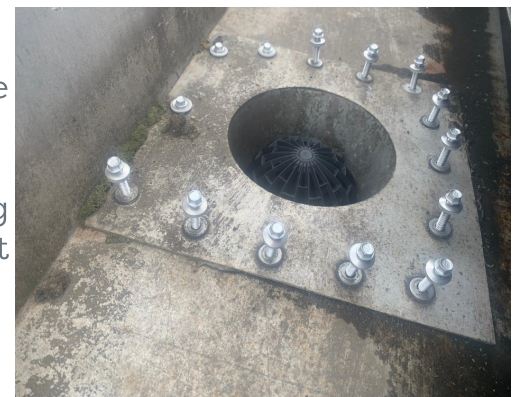
Carbon steel screws, bolts and other fixings had been used in this case.

These now have deteriorated with heavy rust to such an extreme that some fasteners have fallen out all together.

Stainless steel screws are required to all aluminium flashings and interfaces.

Ensure the correct and specified materials are used during the building process as these types of defects may well not become apparent for many years.
