Quality Alert

Wall Cabinet Installation

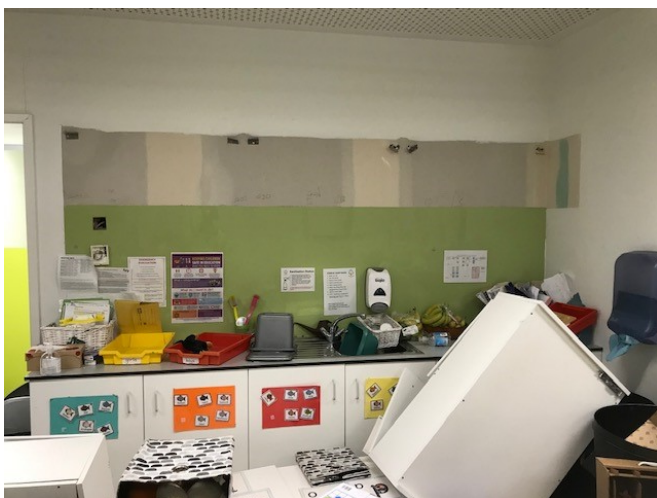
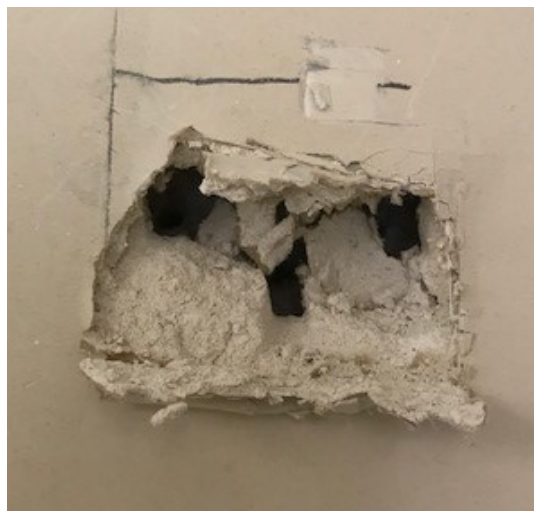
In the investigation it was identified the 3No. Wall units were fixed across a drylining stud wall and an external block work wall. It was identified the reason the wall units came away from the wall due to fixing failure. The external block work wall detail B06 on the architect drawings shown it to be a skimmed plaster wall block work finish, this detail was changed to a dot n dab plaster board finish, with adjacent drylining wall system to B02 detail which included full height timber pattress. The 3 units were fixed to the wall that spanned both the drylining stud wall and the external block work wall also fixed together to ensure all units lined up. Each unit had the correct hanging bracket installed to the wall, fixings used within the drylining wall were 3no. 75mm x 10 screws. The fixings used for the wall brackets to the block work/dot and dab plaster board finish were brown 7mm rawl plugs and 50mm x 10 screws.

The fixing failure was due to the rawl plug installed by drilling through the plasterboard into the blockwork placing the rawl plugs flush with the plasterboard finish meaning the rawl plugs only penetrated the blockwork by 10-15mm due to the void with a dot and dab plasterboard system, with this installation the rawl plugs were not installed as to manufacturers recommendations.

With the 3 units installed as mentioned above the right hand unit would have slowly pulled away from the wall as the units were loaded with school equipment until the unit pulled away from the wall bringing with the other 2 with them in a domino effect.

- **Ensure changes go through the change control process**
- **Ensure the site management inform the supply chain of the changes**
- **Ensure the supply chain are aware of the required fixings to meet the change**
- **Check the wall cabinet fixings are suitable for the wall construction they are being fixed to**
- **Record all changes to drawings and fixings within the ITP process**
