Quality Alert

Anti-climbing fencing installation

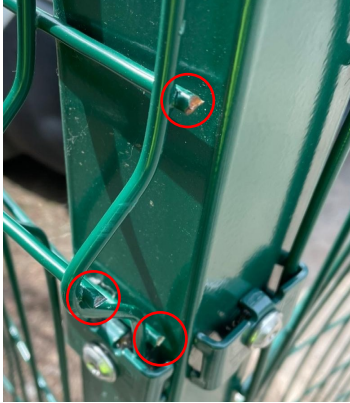
Recently, a person sustained an injury to the upper arm when collided with the corner end of the anti climbing fencing. The cut end had sharp protrusions where the horizontal runs were cut with bolt croppers and not dressed. Photo below

The installation requires, the fence panel to be cut with a disc cutter and all burr removed, the cut end should be as close as possible to the vertical bar, and recoated with the matching paint. Where a panel is to be cut, that cut edge is the face towards the previous panel fitted.
