# Window Defect – Safety Near Miss

SHE-ALT-2023\_14

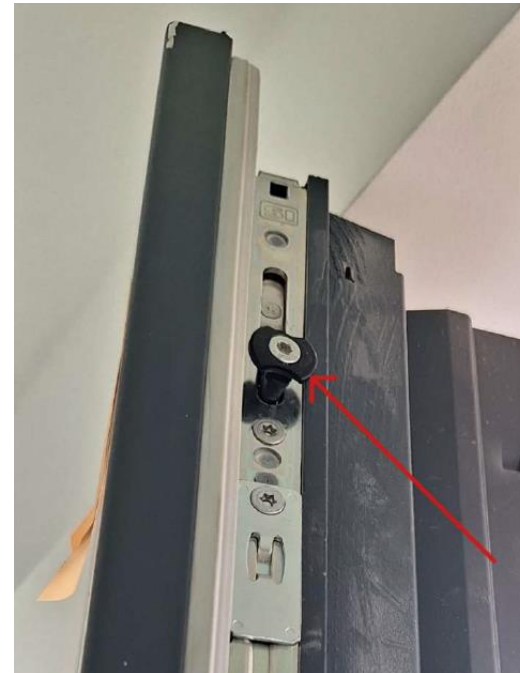
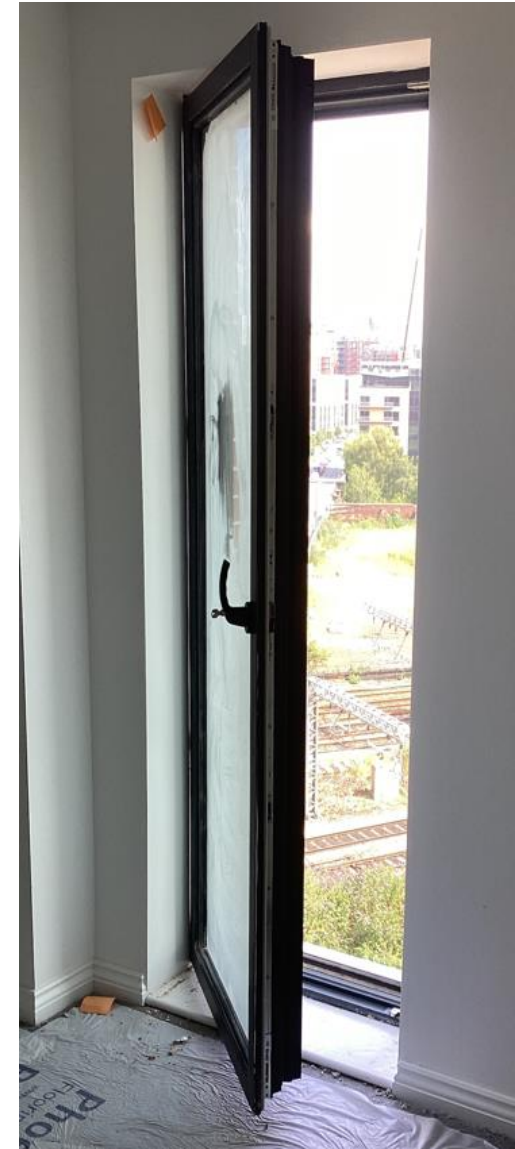
A tilt window has accidentally been installed as an opening door at high level within the building. There was no form of edge protection or restrictor to limit the opening of the door. There was a risk of falling from height.

The “anti turn clip” or “screw” had not been fitted to the opening mechanism to restrict the movement of the handle – this clip should have been fitted to restrict the mechanism and handle movement to Tilt only. With this missing the mechanism was able to function as a door opening.

- Both window and door units are manufactured with the same type of opening mechanism. Its function is determined by the fitting of the anti turn clip. QA checks at manufacture and installation failed to identify the issue.
- Window remained installed without handles in the locked and closed state until permanent handles were fitted at a later date and the issue was highlighted and rectified.

- Agree the necessary Inspection Test Plan with subcontractor for checking defects at delivery or install stages.
- Monitor QA checks at the correct stages and ensure any defects are clearly communicated, recorded, and rectified.
- Liaise with window manufacturers about their manufacture processes, and understand any design implications which may cause safety issues on site.
