Standing seam roof/s

Summary

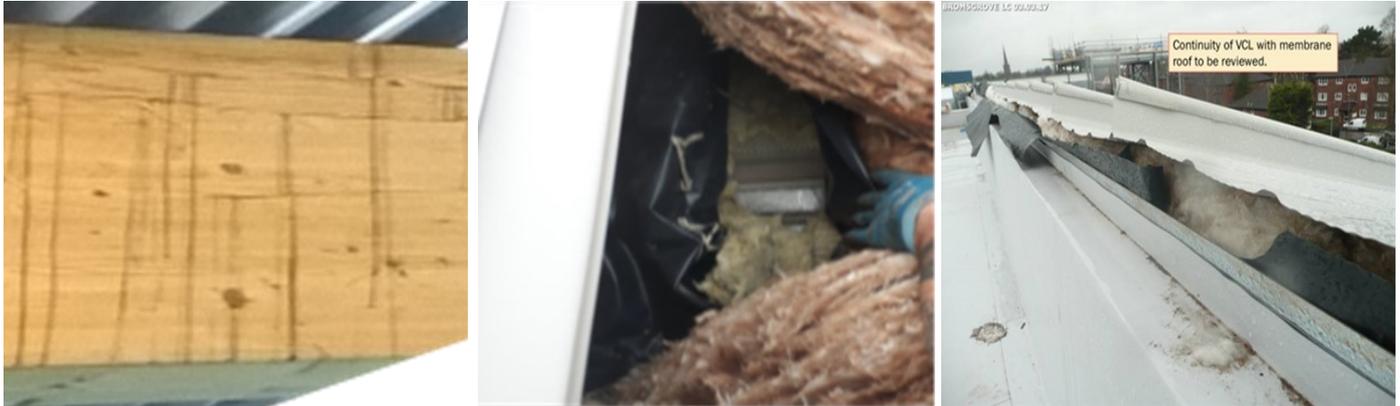
The Sports Centre was completed 12 month prior, They reported staining down the glulam beams to the pool area. Pools by there nature have high humidity environments, which requires specific controls and design features.

An in-depth inspection of the roof by a roofing specialist, reported the following on removal of some roof sheets:

- Condensation/ moisture evident through the various layers from the underside of the top sheet to the liner sheet
- Condensation/ moisture was holding in the roof due to the lack of design in ventilation
- The condensation/ moisture was able to bleed through the VCL because the lap seals were incorrect and poorly installed.

- Plan drawn up of how to replace the roof elements down to the liner sheet without having to close the pool.
- New roof design acquired and approved but the client
- Internal works to the glulam beam to be carried out, out of hours.
